## Abstract

For centuries, dimension stone marble exploitation from the Estremoz Anticline, south Portugal (1), lead to a peculiar landscape consisting of hundreds of deep open pit quarries.

Within the scope of the Intervention Plan in Quarries Under Critical Situations (2019-2021), approved at the meeting of the Council of Ministers, on February 7 (RCM 50/2019), the University of Évora carried out 34 slope stability studies in approximately 40 exploitation cavities for ornamental marble. The paper presents a summary of the main situations that were identified as well as the measures recommended for their mitigation.

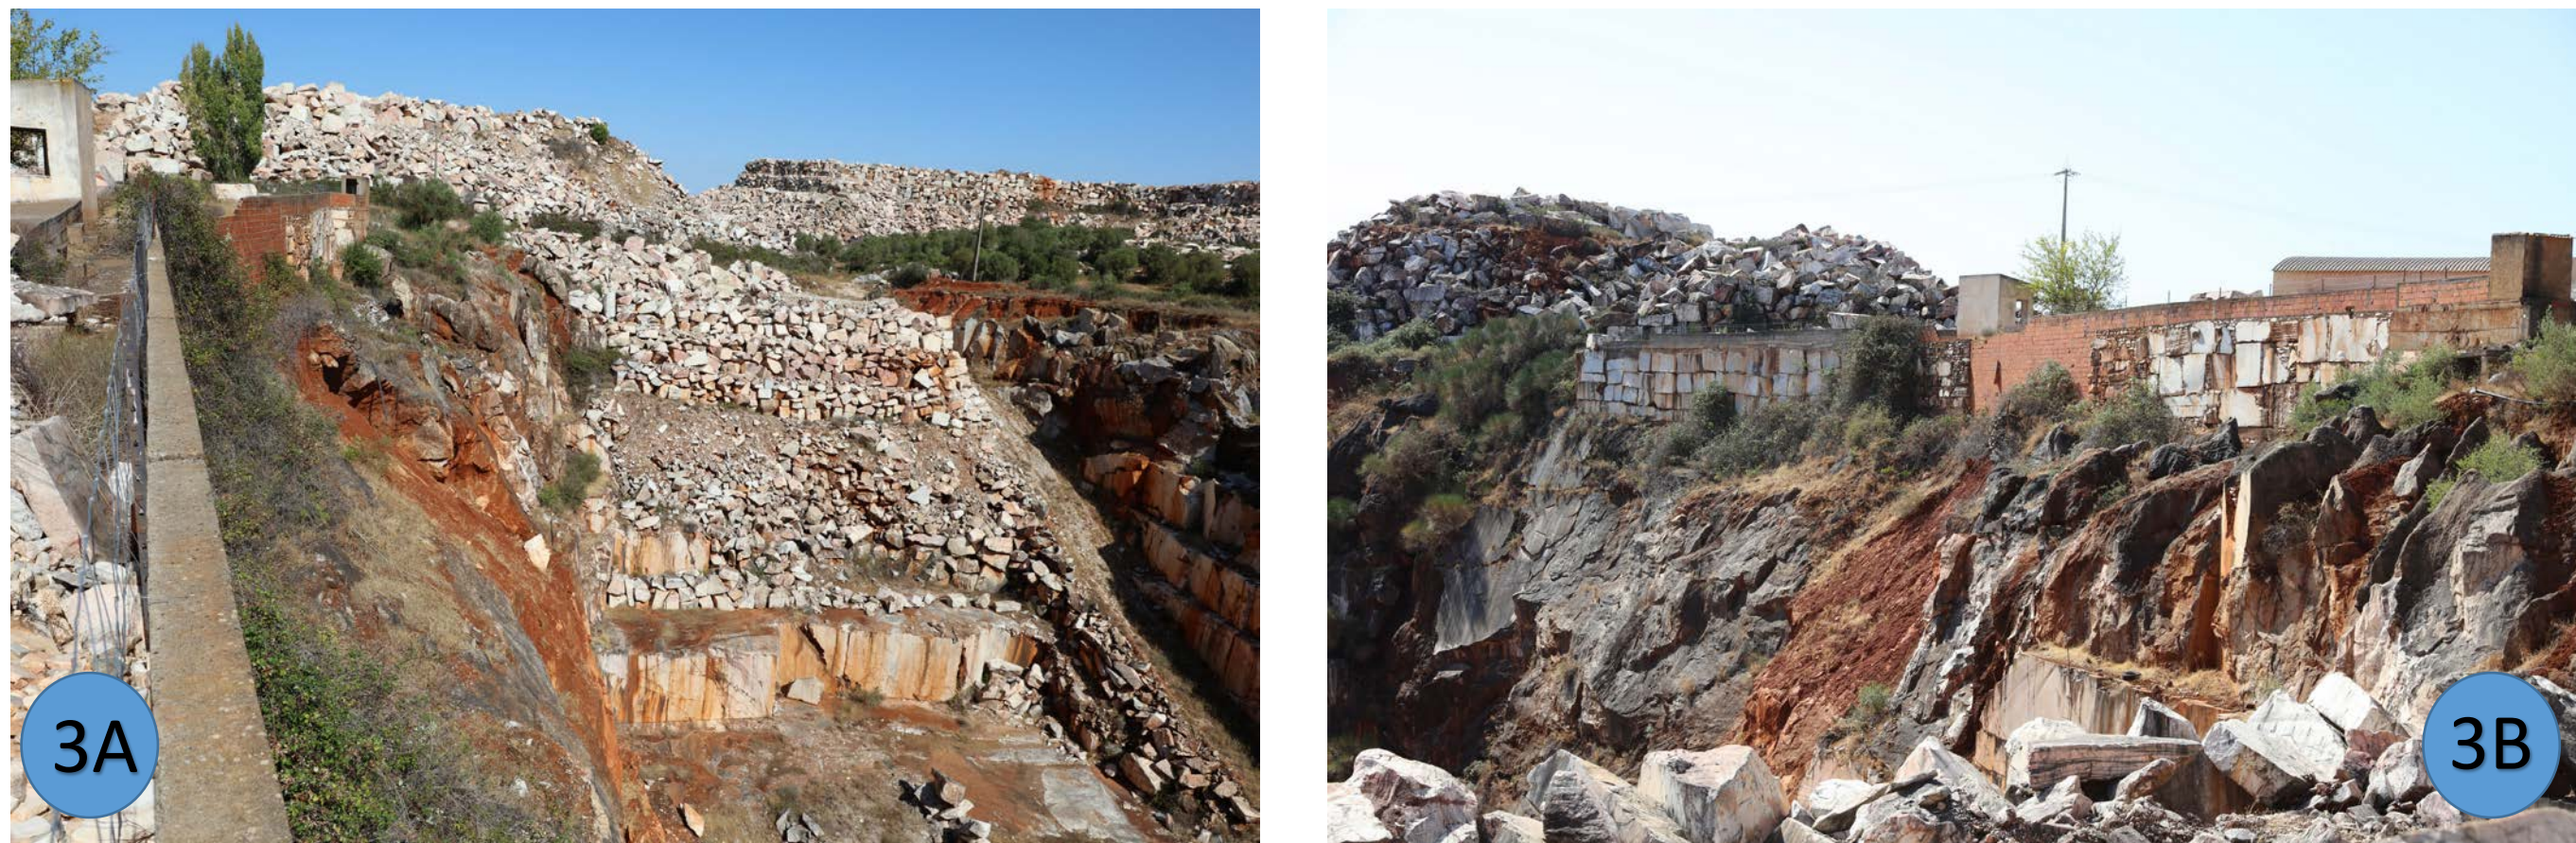
(3) Example of slope stability of the southwest slope in a quarry with suspended mining, which configures a situation like to that of the M255 road, with the "Dips" software. In truth, and luckily, situations like this are not the most common. (3A) View to the northeast; (3B) Southwest view; (3C) Planar sliding situation; (3D) Wedge sliding situation.

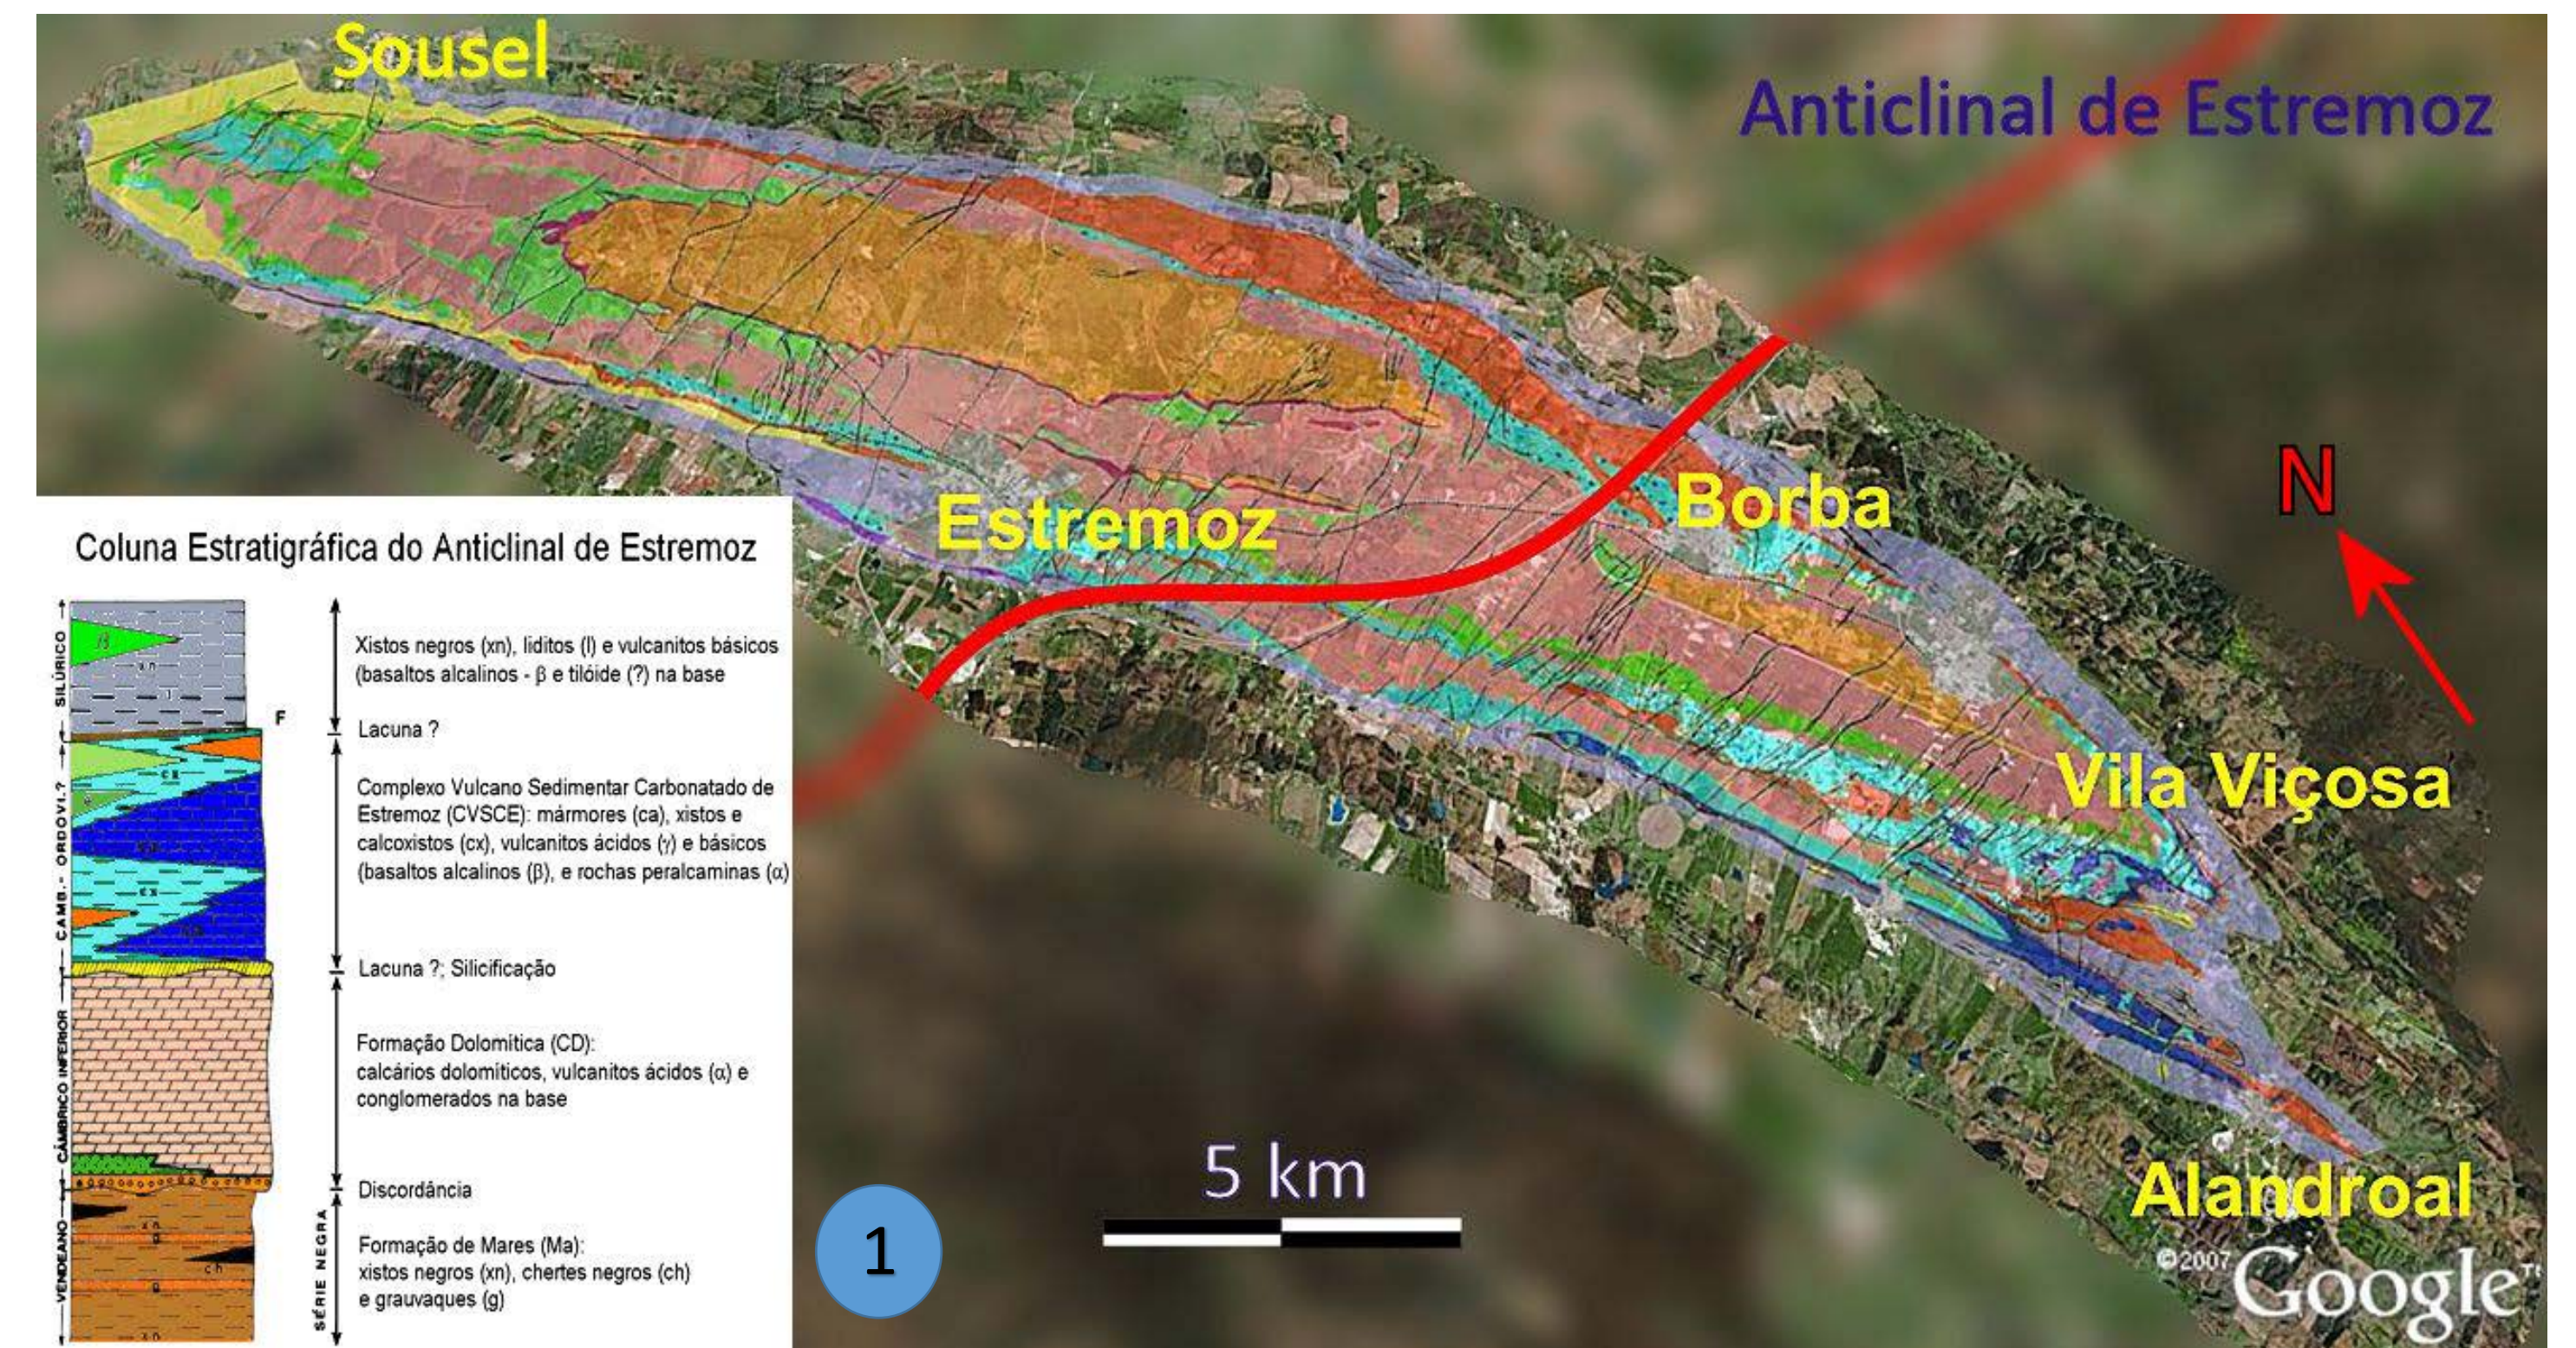
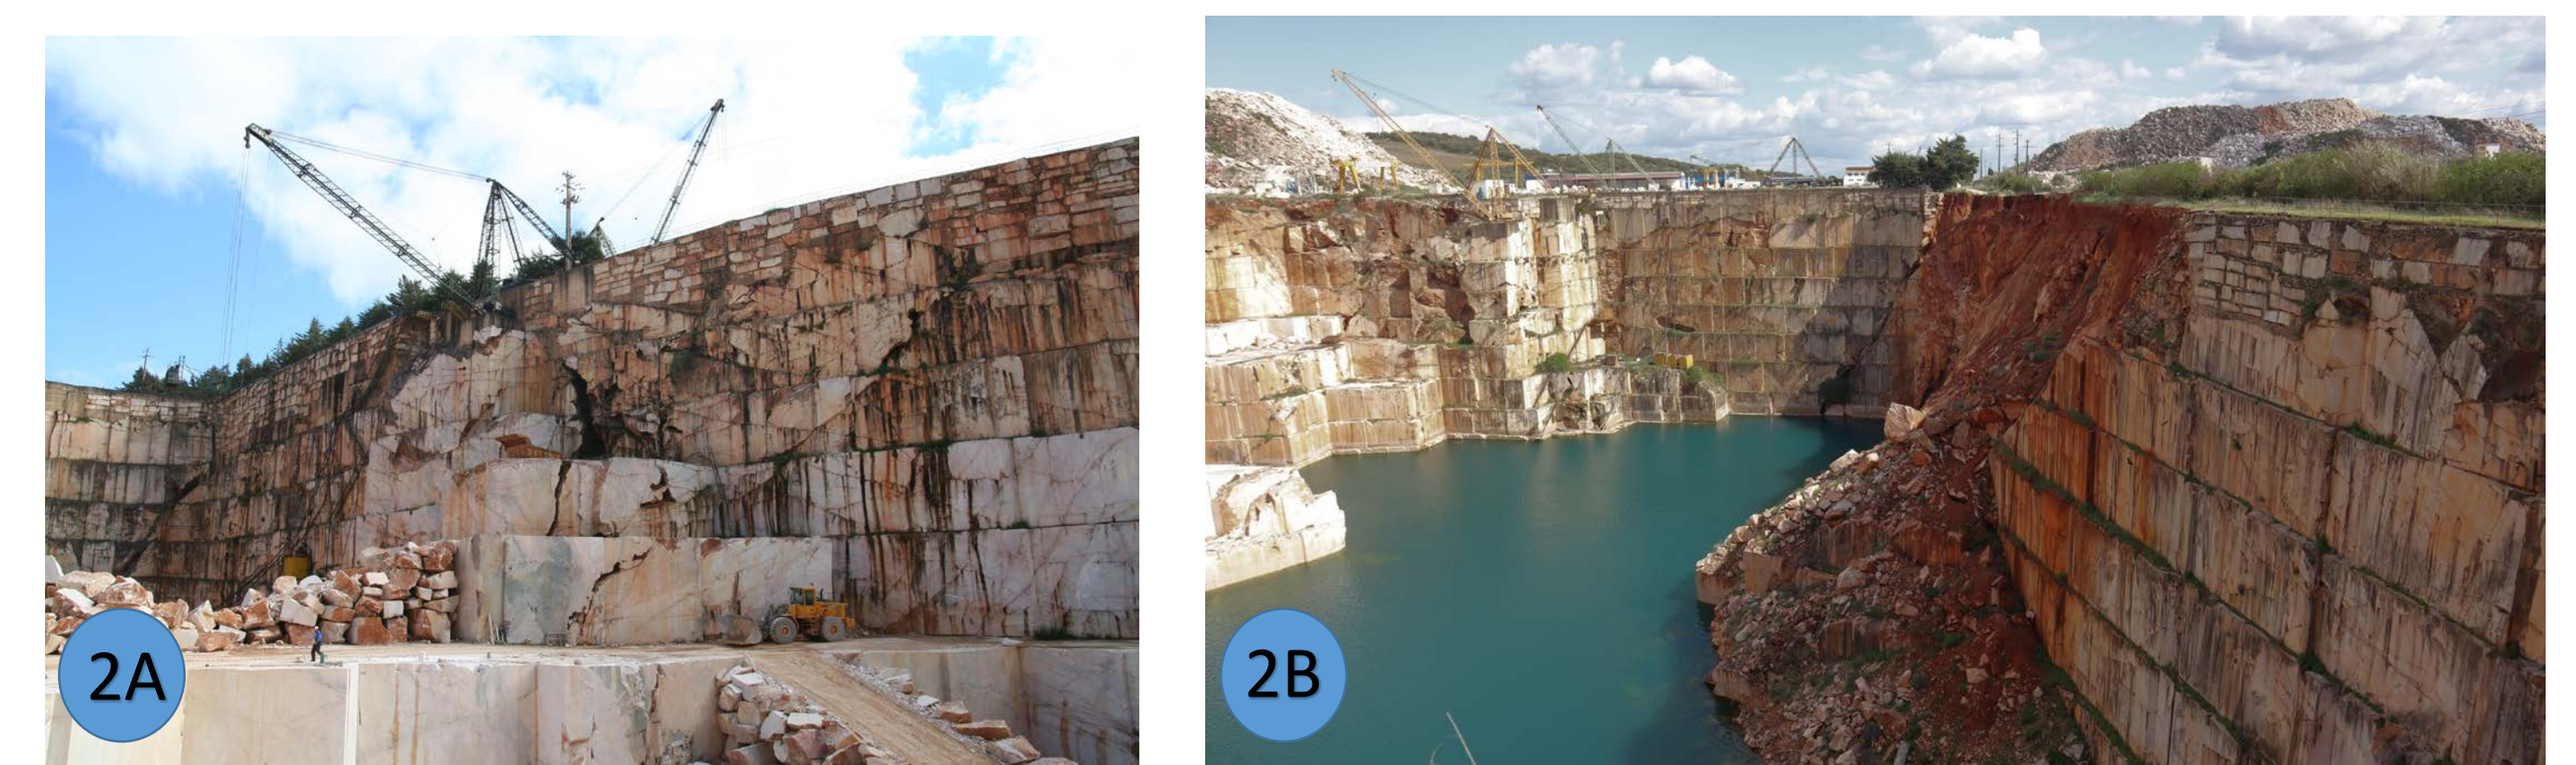
As the quarries reached greater depths, in several cases over 100 meters, issues related to the slope stability became more evident and dangerous (2A). Even so, it took an accident that caused 5 deaths due to a slope collapse that destroyed a municipal road (2B), for public entities to pay more attention to this issue.

(2A) Quarry located next to the municipal road M255 that would eventually collapse (2B) at 15:45 on November 19, 2018, with an approximate length of 100 m. As a detail, note the lack of arboreal screen on the crest of the slope in (2B).

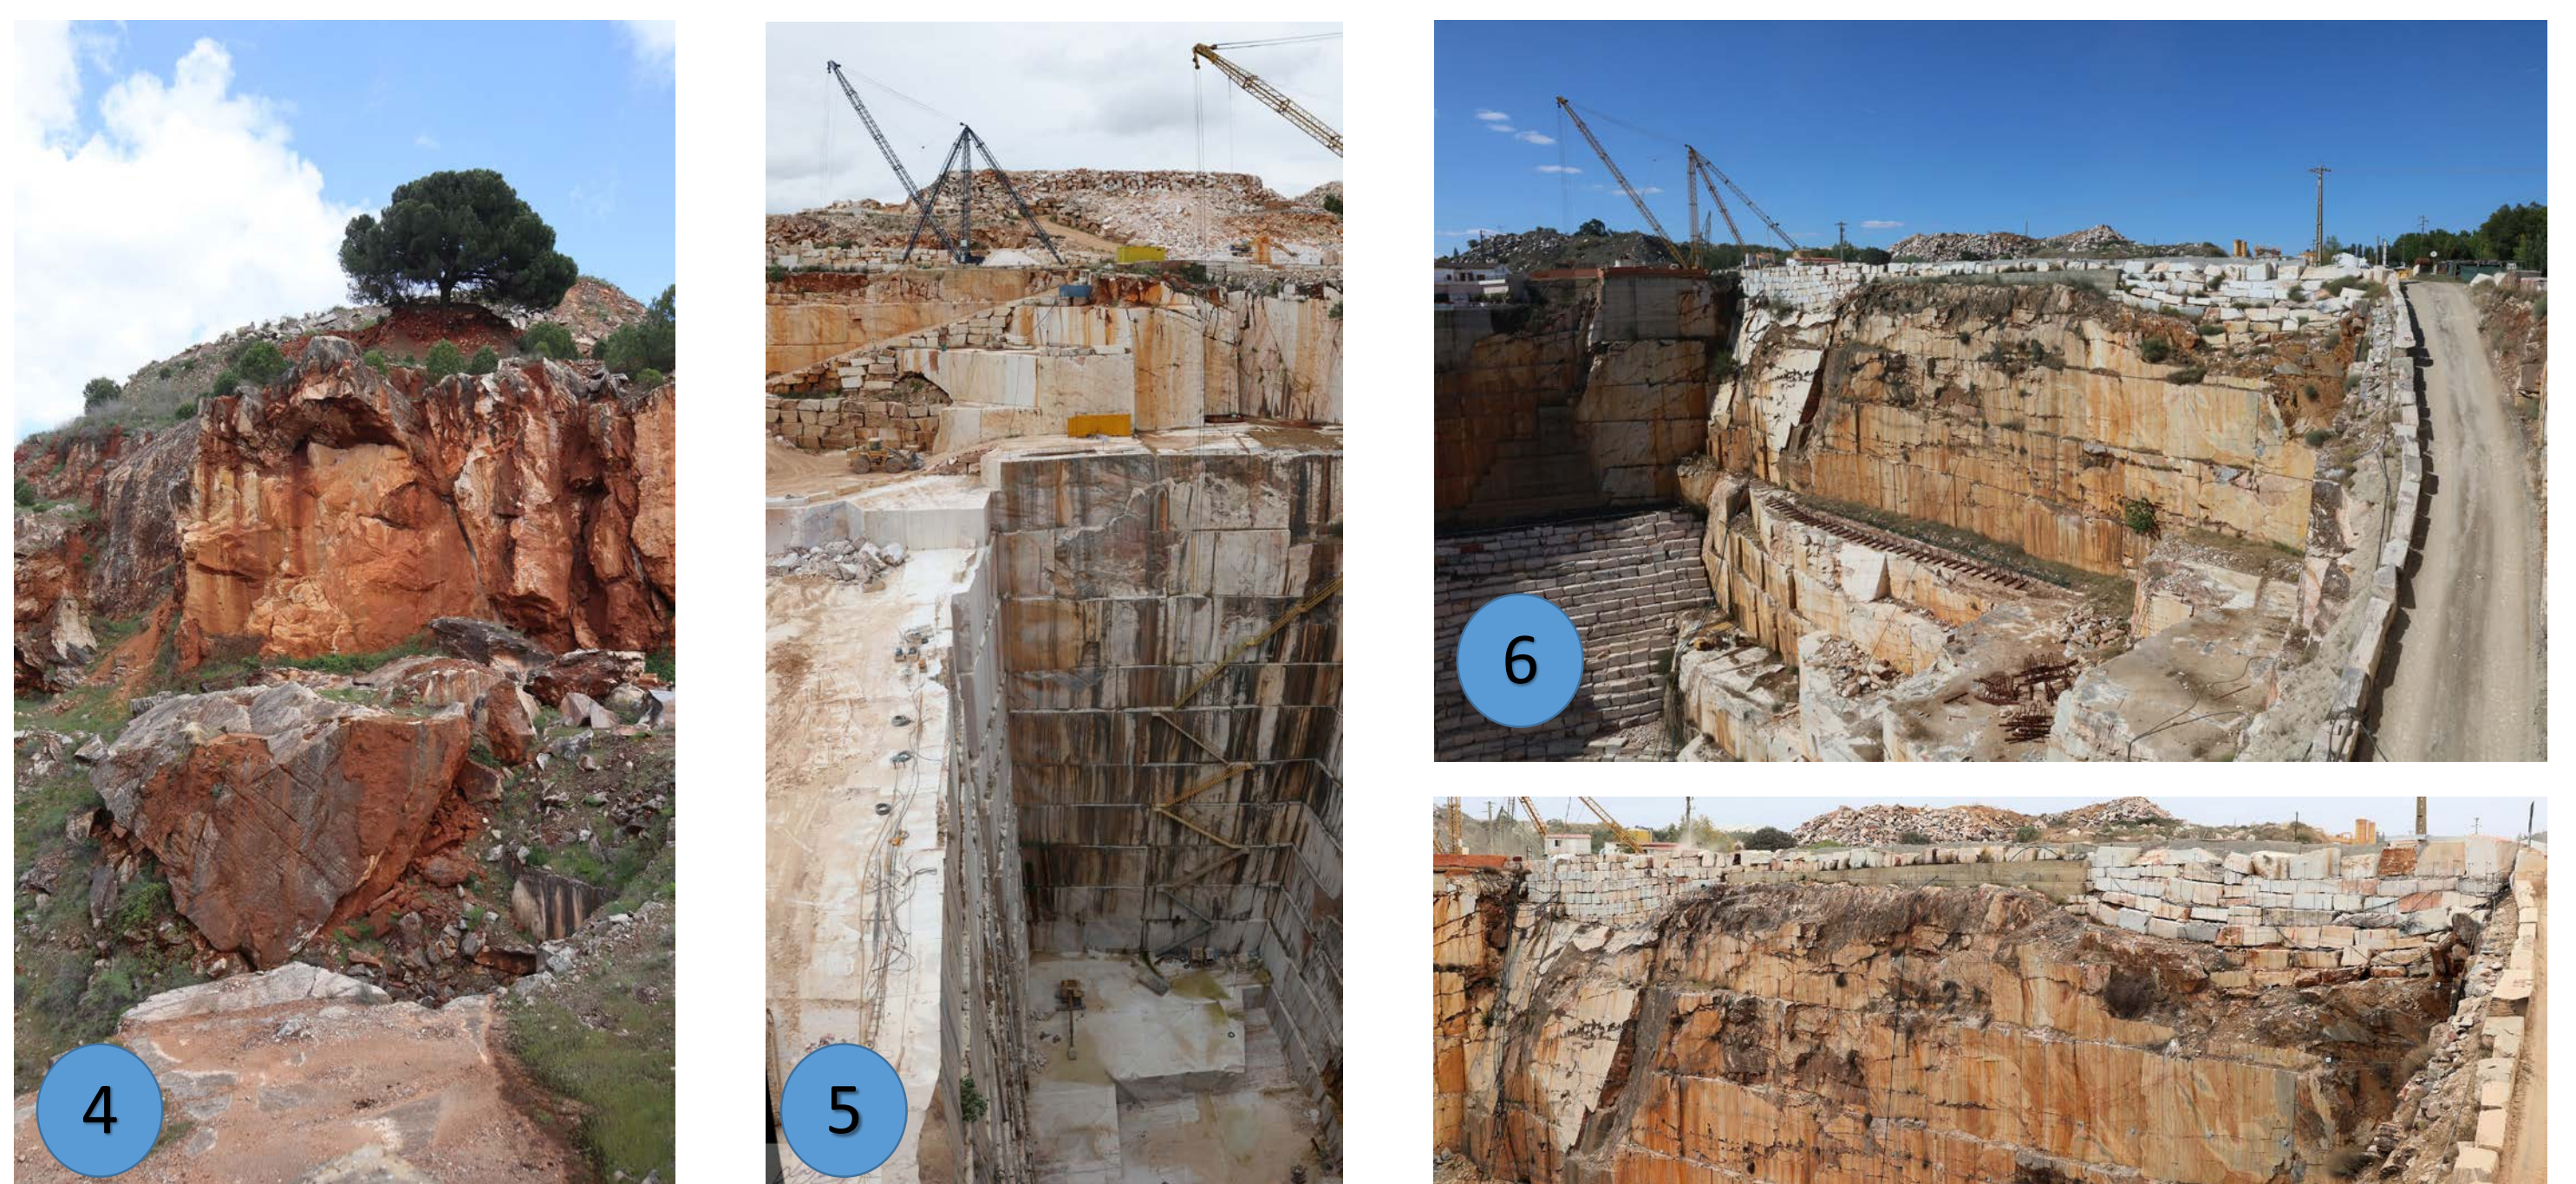
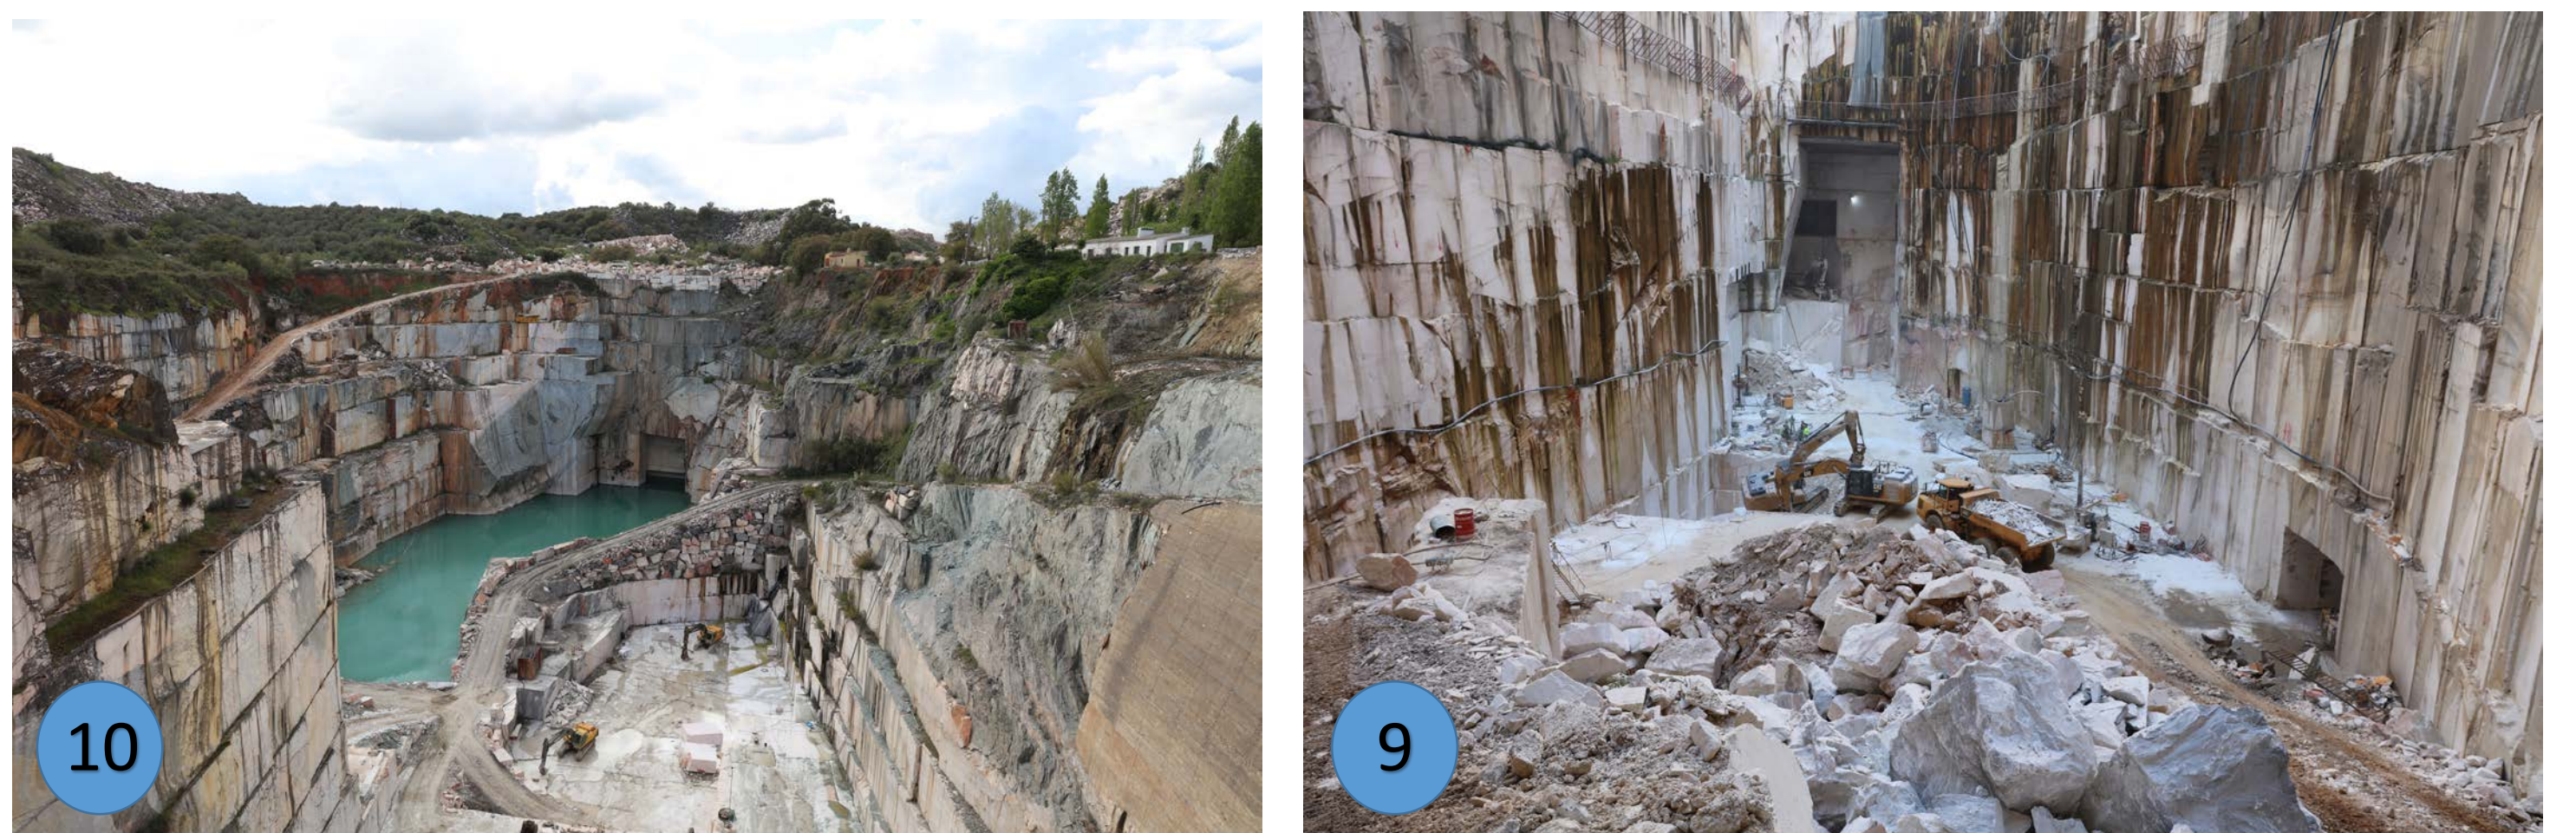
- fall of a large block in an abandoned quarry with the heap invading the cut;
- two quarries with no defense zone between them but with different exploitation levels;
- northeast slope of quarry with several situations of imminent risk identified;
- geotechnical intervention aimed at consolidating the slope at risk of falling, note that the bottom of this quarry reaches 150 meters (9), and only when there is no risk of fragments falling or any rupture, into the cavity, is that it will have an exploitation license again;
- details of the work carried out;
- example of bad practices by ambitious mining with development of an underground quarry following the marble deposit but leaving behind slopes in shale whose stabilization requires costly intervention, the exploration was abandoned.
