Mortars and Renders: The Case of the Roman Villa Horta da Torre Fronteira, Portugal

Abstract: The archaeological site of *villa* Horta da Torre in Portugal reveals distinctive architectural features within the context of Roman *villae* in Hispania. Notably, the *triclinium* was designed with an artificial cascade originating from a double apse wall, and the walls were adorned with mosaic *tessellae* panels and marble skirting. During the Roman era, the surrounding area belonged to the former province of *Lusitania*, with *Augusta Emerita* serving as its capital. This study examines 11 mortar samples from various contexts and functions, such as masonry, preparatory, render, and *opus signinum* mortars. A set of complementary analytical techniques was employed to determine the textural and mineralogical compositions of the mortars. The aim was to gain insights into the production techniques and the selection of raw materials within the geological context of this rural construction. It was observed that the processing of raw materials and production techniques did not always adhere to the rules of Vitruvius. A comparison with other villas revealed comparatively less meticulous attent

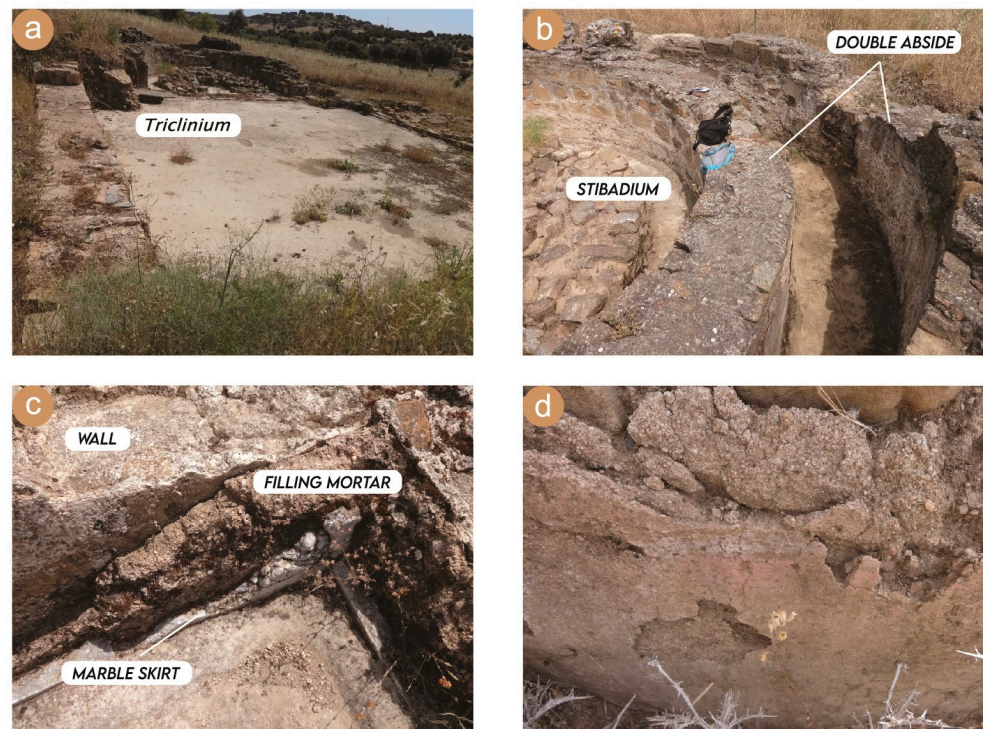
Figure 2. An overview of the different parts of the site: (a) a perspective view of the main banquet hall (i.e., *triclinium*); (b) walls of the double apse (abside) structure; (c) marble cladding working as a skirting, filling mortar layer and the structural wall is visible; (d) survived part of the mural painting from inside the room.

The *villa* featured a spacious reception room, the *triclinium*, for hosting guests. It had an area of about 90 m² (Figure 2a) and was situated on its northern side. Adjacent to it, there is a double apse structure interpreted as a water reservoir positioned behind the *stibadium* (Figure 2b). As a decorative eccentricity, the *triclinium* had an artificial cascade originating from the apse's wall that would offer a playful water system covering its floor. The *triclinium* walls were adorned with mosaic *tessellae* panels, while the skirting was covered with marble slabs (Figure 2c). Mural paintings were preserved in the small *peristylum* (Figure 2d). The unique indoor environment of the *villa*, sophisticated technical interventions, and ornate decorations collectively contributed to an impressive ambiance that was undoubtedly enjoyed by the distinguished guests invited by the affluent owner of the *villa* [17,18].

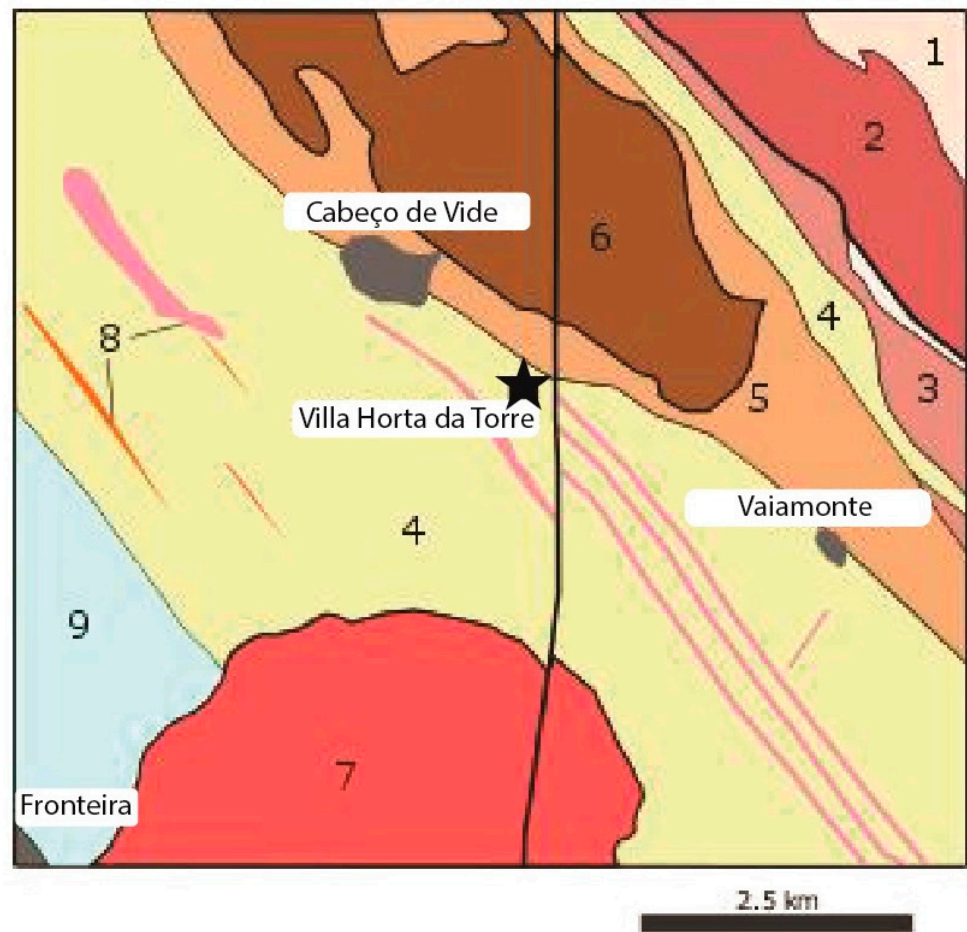
Figure 3. Simplified geological map of the *villa* Horta da Torre extracted and adapted from geological map 32-B (Sousel) and 32-B (Portalegre) at a scale of 1:50,000 (both Gonçalves, 1973). Numbers correspond to the following: 1—shists and greywackes; 2—biotitic granite orthogneiss; 3—hyperalkaline granitic or syenitic orthogneiss; 4—conglomerates and arkoses; 5—hornfels (quartzitic, pelitic, and calcosilicate); 6—ultrabasic-basic intrusion of Alter do Chão; 7—crystalline limestones; 8—schists, quartzite and grauwaques; 9—granitic dykes.

The Roman *villa* is located within the geological context of the so-called Iberian Massif, specifically in the Ossa–Morena Zone. The black star on Figure 3 indicates the approximate location of the *villa*. This broad area is characterized by a diverse range of igneous and metamorphic rocks (Figure 3), predominantly oriented in a northwest–southeast (NW–SE) direction, roughly perpendicular to the flow of water lines into the southwest (SW). In detail, the *villa* was built on a geological substrate of metamorphic rocks, including schists, quartzites, and greywakes that outcrop in its vicinity. Other than the metamorphic rocks, to the north lies an igneous ultrabasic and basic intrusion, partially serpentinized, known as the Alter do Chão intrusion. This elongated intrusion aligns with the Variscan structure, which began a contact aureole in the regional limestone and dolostone. Further southwest, a calc-alkaline granite intersects the regional metamorphic rocks.

Extending from the northeast (N-E) to the southwest (S-W) and encompassing Horta da Torre, the water lines sequentially traverse shists and greywackes, orthogneisses, hyperalkaline granitic or syenitic orthogneisses, conglomerates and arkoses, the aforementioned intrusion of Alter do Chão surrounded by hornfels (quartzitic, pelitic and calcosilicate), crystalline limestone and dolostone, and culminating in the unit where the Roman *villa* is situated. This entire sequence is intersected by a north–south fault passing approximately 500 m east of the archaeological excavation site. The nearest stream, the Verdigão stream, located 100–200 m away, flows from N-E to S-W with an intense flow, even during the summer season.

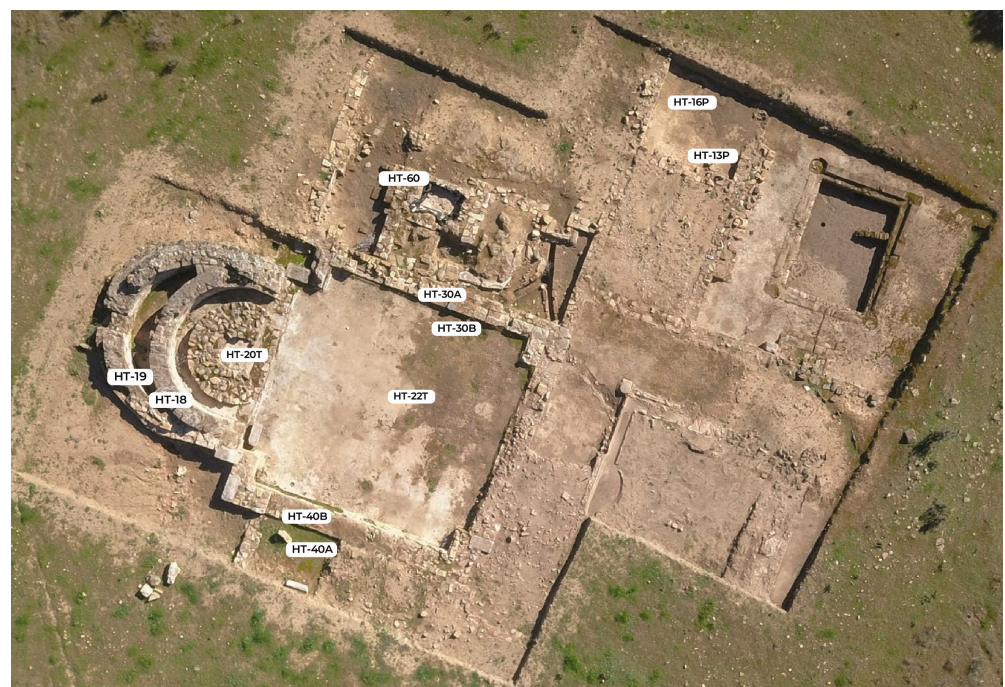
Figure 4. Aerial view of the archaeological site of Roman *villa* Horta da Torre in Alentejo, Portugal, highlighting sample extraction locations for the study. (Photo credit: Geo-Drone).

Eleven mortar samples were collected from distinct locations within *villa* Horta da Torre, corresponding to their specific functions in the building (refer to Figure 4 for extraction points). Notably, HT-13P and HT-16P were painting/rendering mortars used for mural paintings in the peristyle. HT-18 and HT-19 served as masonry mortars extracted from the inner apse and outer apse, respectively. HT-31A and HT-40B were obtained from the narrow south wall and wider north wall, respectively, both designated for masonry purposes. HT-60 was collected from the water tank wall and was also intended for masonry applications. For specialized applications, HT-20T was sourced from the ceiling above the *stibadium*, and HT-22T originated from the southwest wall of the *triclinium*. Both mortars were utilized as preparative materials for wall mosaic tesserae. Additionally, HT-31B, extracted from the narrow south wall, and HT-40A, extracted from the wider north wall, served as filling material between the wall and marble (slab) cladding. This categorization and extraction information provides a comprehensive insight into the diverse mortars utilized in various architectural elements of the *villa*. Sample collection was conducted under the guidance of an authorized archaeologist, with prior approval from the municipality of Fronteira, Portugal.

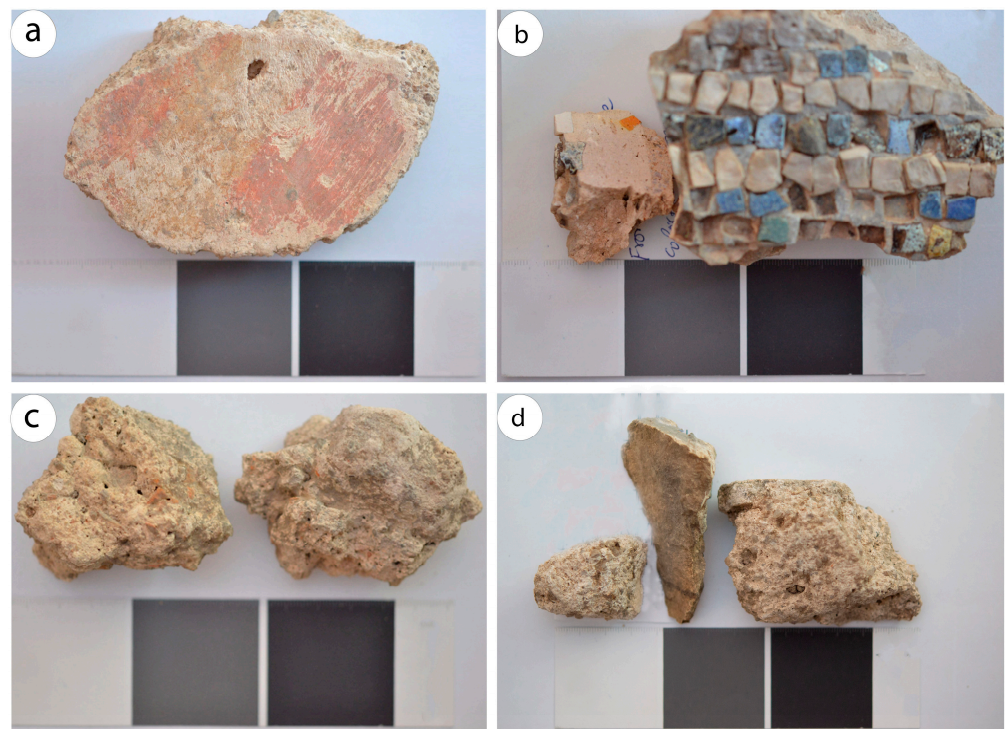
Figure 5. The representative mortar samples; (a) Group 1 (G-1): Painting mortar/render with chromatic layer (samples with stratigraphy); (b) Group 2 (G-2): Preparation mortars with tesserae (samples with stratigraphy); (c) Group 3 (G-3): Filling mortars between marble skirting and wall; (d) Group 4 (G-4): Masonry mortars.

This section provides detailed macroscopic and stereomicroscopic observations of mortar samples collected from various locations, systematically categorized into four groups based on their functions. The above Figure 4 illustrates the locations of the extracted samples, while the Figure 5 visually represents the different mortar groups. Group 1 (G-1; Figure 5a) comprises wall painting mortar samples with a chromatic layer. Group 2 (G-2; Figure 5b) includes preparation mortars for wall mosaic tesserae (*opus sectile*). Group 3 (G-3; Figure 5c) consists of filling or preparation mortars located between walls and marble slabs or wall skirtings. Group 4 (G-4; Figure 5d) comprises masonry mortars used for joining stone layers.

Mortar samples from G-1 and G-2 exhibit stratigraphy. Table 1 summarizes the type of mortars, including information on their characteristics, construction period, function, and location within the *villa*. Macroscopic observations, conducted with the naked eye and a digital camera, reveal the heterogeneity of the mortar samples. The composition includes a light-colored binder and a variety of aggregates differing in color, shape, and size. Lime lumps are prevalent in most of the samples, suggesting incomplete lime extinction, possibly due to insufficient water or time required for lime slaking [20–24].

Painting mortars in G-1 (HT-13P and HT-16P) showcase a reddish chromatic layer over a preparatory/render layer known as *arriccio* (Table 1). These mortars exhibit a disrupted, very thin lime layer (<1 mm), with no observed intermediate layer corresponding to an *intonaco*. Their appearance is heterogeneous, characterized by a gray color and varying sizes and colors of aggregates. Lime lumps and ceramic fragments are also present.

Preparation mortars for wall mosaic tesserae (G-2, HT-20T and HT-22T) display clear stratigraphy with tesserae of different origins/compositions and colors embedded into lime (Table 1). The sequence observed from top to bottom was as follows: (1) tesserae were embedded into a (2) supranucleus, primarily consisting of lime (~1.5–2 cm thick) with rare aggregates of slightly pink/orange color, and a (3) nucleus layer of reddish/orange color with compositionally varied aggregates, including ceramic fragments. This observed stratigraphy aligns with findings from other analytical studies of mosaic preparation [25].

Filling mortars in G-3 (HT-31B and HT-40A), collected from thin and thick walls, respectively, were used to attach marble slabs (skirting) to the walls. They appear light gray and heterogeneous, containing various aggregates (minerals and stones), ceramic fragments, and lime lumps (Table 1).

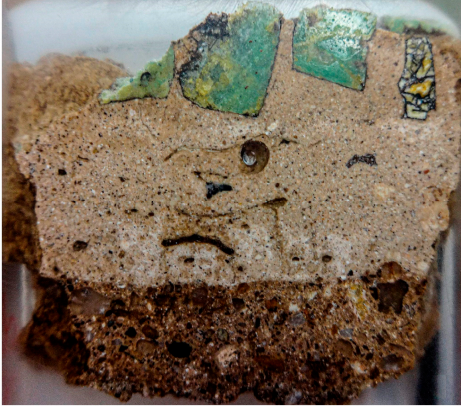
| Group | Sample | Location | Stratigraphy | Description |
|--|---|---|--|--|
| | HT-22T | <i>Triclinium</i> Southwest Wall | | The top layer of the colorful mosaic is embedded in a hard, light gray lime bed, working as a base for the mosaics. This layer of mortar is compact, porous, and homogenous. The third layer is non-porous with dark gray stone aggregates. |

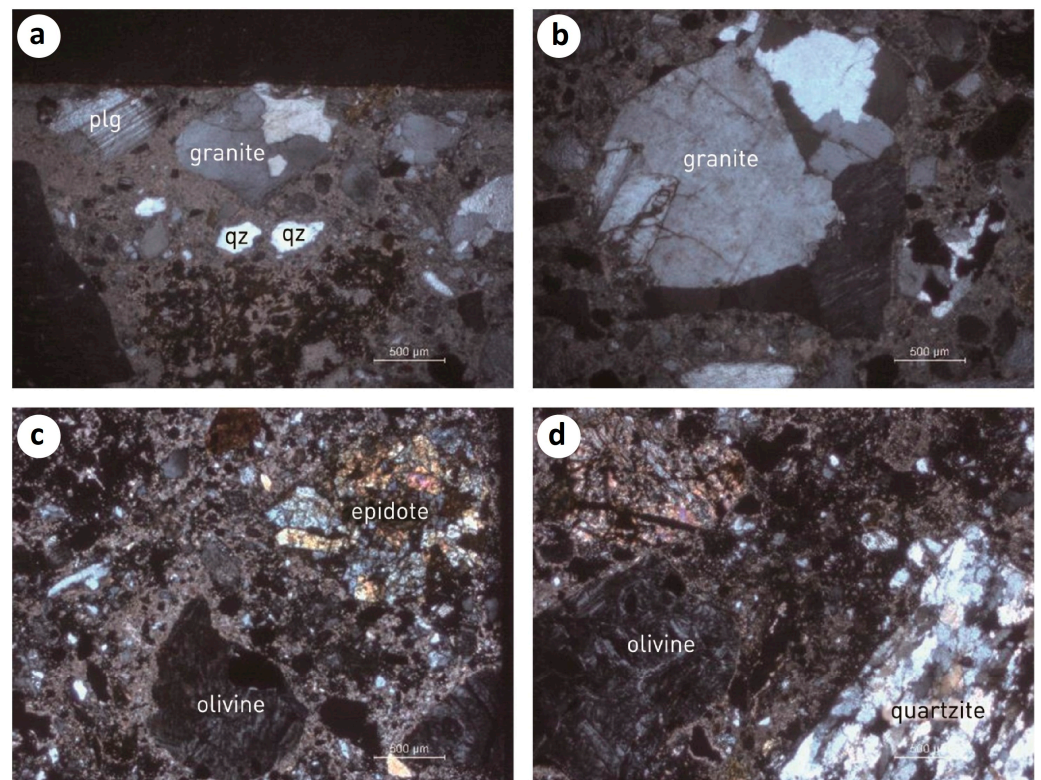
Figure 7. Representative microphotographs of the mortar samples: (a,b) showcase the overall appearance of the mortar in the HT-13P sample, revealing granite grains and plagioclase (plg). In sample HT-60, (c) displays olivine and epidote; (d) exhibits olivine and quartzite.

The observed sample, HT-13P, typically presents a continuous microcrystalline binder with a red chromatic layer. The overall appearance of this mortar sample reveals granite grains and plagioclase (plg), as demonstrated in Figure 7a,b. Additionally, Figure 8a shows a reddish paint layer on the top, along with calcite binder and quartz. The mortar displays heterogeneity with angular large granitic grains, smaller quartz and plagioclase, alkaline feldspar grains, and rarer biotite and ceramic fragments. A thin and discontinuous preparatory layer is visible, with aggregates occurring at the surface, associated with the red pigment.

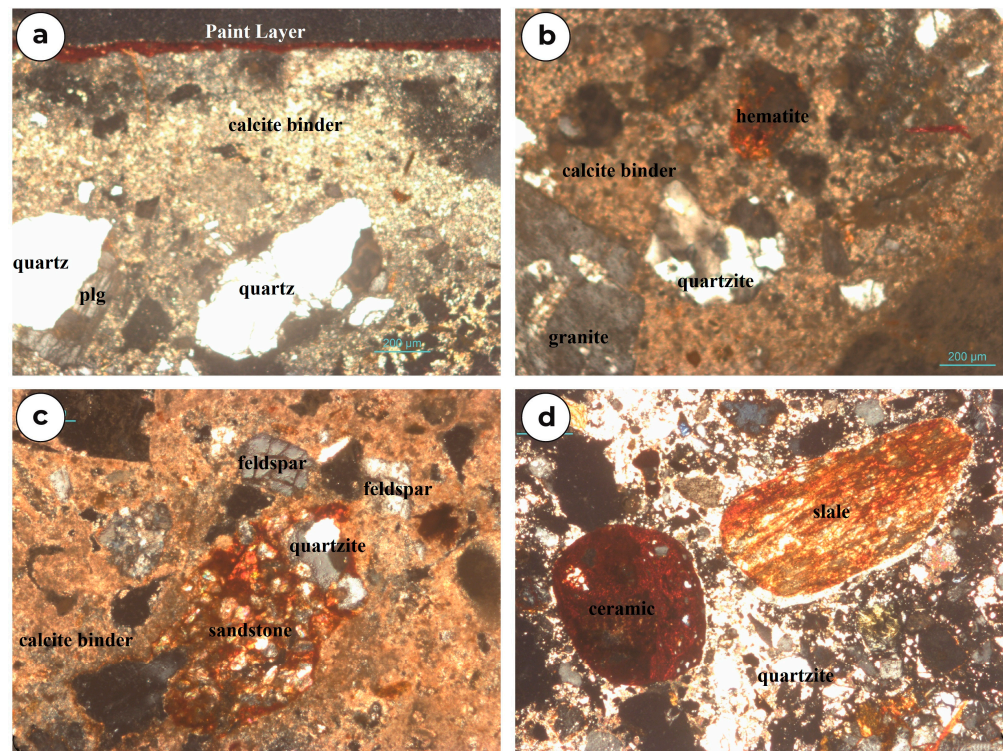
Figure 8. Representative petrographic images of the mortar samples: (a) HT-13P shows a reddish paint layer on the top, calcite binder and quartz; (b) HT-22 reveals calcite binder, hematite, granite, and quartzite in the bottom layer; (c) HT-40A shows quartzite, calcite binder, and feldspar in the mortar bed; (d) HT-60 exhibits ceramic fragments, quartzite, and slale.

Samples from Group 2 (Figure 8b) present similar features. The top layers have microcrystalline granularity and disperse fine particles of clay material. The observed tesserae are composed of glass (green) and limestone (white). The transition between layers is well defined, albeit with an irregular contour at the observed scale. The mortar in the lower layer (*nucleus*) presents a continuous binder with microcrystalline granularity. The aggregates are highly diversified (pyroxene, olivine, plagioclase, alkaline feldspar, ceramic fragments, and quartz) and highly hetero-granular, often presenting angular forms or even crystal faces.

The thin section of sample HT-40A (Figure 8c) from Group 3 mainly comprises quartz and K-feldspar. In addition to ceramics, a wide variety of lithic grains, including metapelite and granitic quartzite, were also observed.

Sample HT-60 from Group 4 presents a heterogeneous microcrystalline binder that envelops an irregular distribution of aggregates. Apparently, there is a decrease in the amount of binder. Aggregates are highly diverse, in a similar way to what was observed in the lower layers of the samples from Group 2 (Figure 7c,d and Figure 8d): olivine (sometimes serpentinized), pyroxene, allanite, oxides, quartzite ceramic fragments, chlorite, amphibole, quartz, and feldspars.

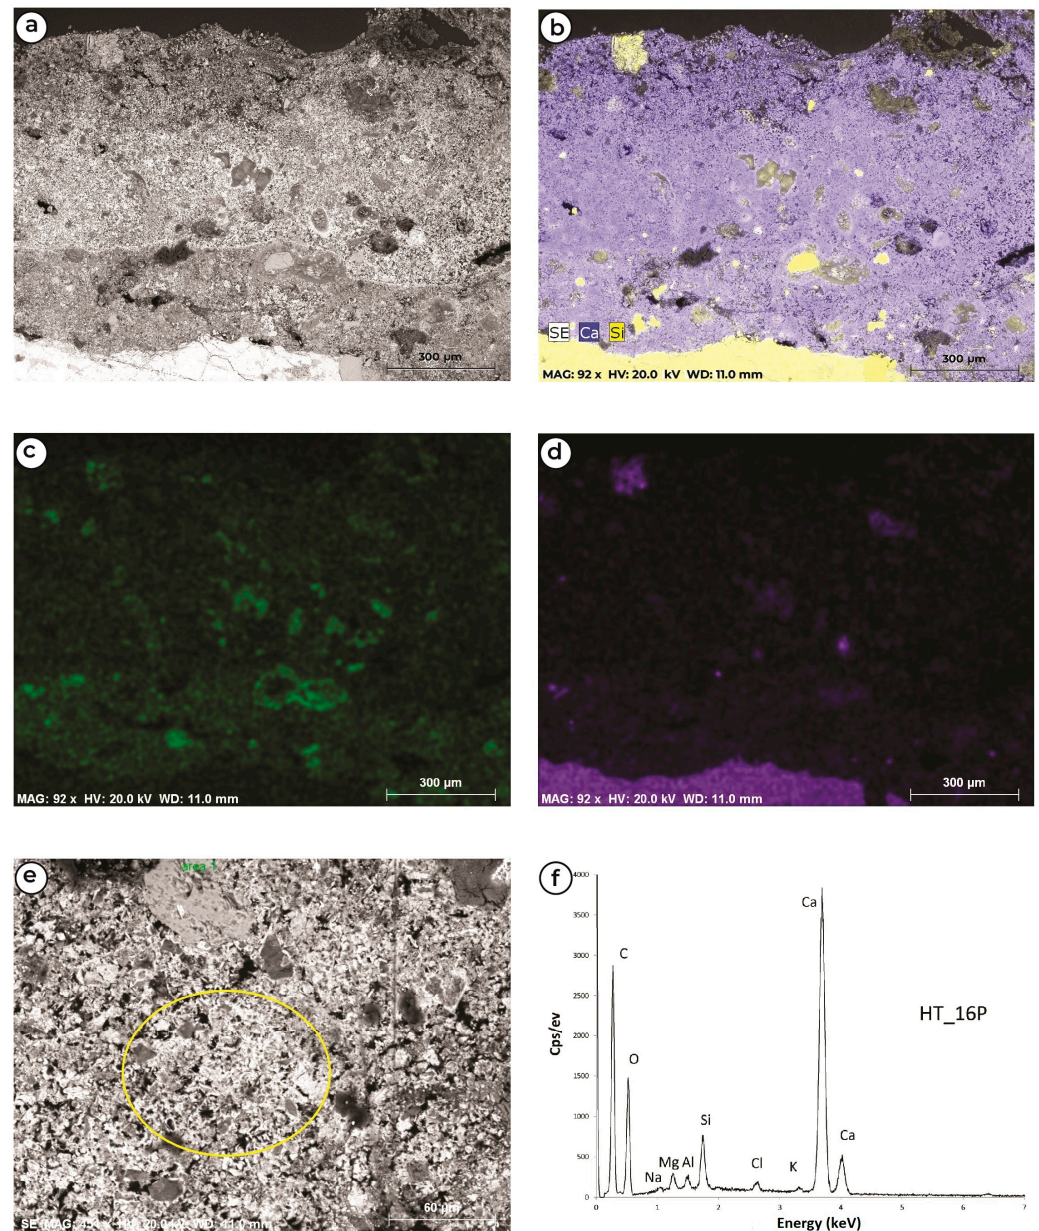
Figure 11. HT-16P: (a) BSE image showing the transition between preparative layer and mortar; (b) BSE and EDS elemental distribution map for Ca and Si; (c) EDS elemental distribution map for Mg; (d) EDS elemental distribution map for Al; (e) BSE image showing of the preparative layer texture; (f) the corresponding EDS spectrum is presented in the yellow-circled area depicted in (e). Samples from G-2 (HT-20T and HT-22T) exhibit a top layer, known as the *supranucleus*, primarily composed of calcitic lime (Ca), as shown in Figure 12, featuring a homogeneous and continuous texture. This layer also incorporates fine ceramic powder (K, Al), contributing to an orange hue, as illustrated in Figure 12e. The underlying mortar layer reveals aggregates of quartz (Si), alkali feldspar (K, Si, Al), pyroxene (Fe, Mg, Si), olivine (Mg), and ceramic fragments (Al, Fe, Mg, K) as depicted in Figure 12.

A variable pressure scanning electron microscope equipped with energy dispersive X-ray spectroscopy (VP-SEM-EDS), operating in a low vacuum system, was used to conduct elemental analysis and determine the composition of aggregates and binders on polished surfaces. The SEM-EDS data not only confirmed and complemented observations made through other techniques but also validated the composition of the binding phase. Both samples of G-1 mortars with paint layer (HT-13P and HT-16P) showed similar texture and elemental composition. Elemental distribution maps and areas analyzed for both samples display calcium (Ca) as the primary element present in the binder. The Figure 11 shows a representative sample, HT-16P. In the analyzed samples, silicon (Si) particles predominantly appeared in the form of quartz, while the association of Si with aluminum (Al) and potassium (K) indicated the presence of K-feldspar, and Al along with Na suggested sodic plagioclase in the aggregates. The preparative layer consisted primarily of Ca-rich aerial lime. The transition from the preparative layer to the lower mortar was marked by a slight increase in Mg and Al (Figure 11a–f).
