# The importance of geotechnical knowledge of terrains: Beja municipality, Alentejo, Portugal

**ABSTRACT:** The municipality of Beja, in Alentejo (Portugal), is presented as a case in which the insufficient knowledge of the geological and geotechnical characteristics of terrains contributes to serious problems in the establishment of building platforms. In Beja three main geotechnical units can be defined: fills, residual soils from gabbro-diorite weathering and gabbro-diorite bedrock. The knowledge of location, thickness and geotechnical properties of all these formations will contribute to the accurate engineering design and construction work, and also to support urban planning and therefore to minimize geological risk by avoiding zones with thick problematic soils as shown with a case study.

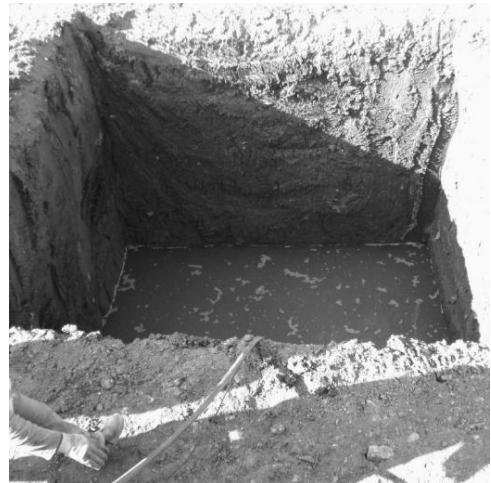
During the excavation works for the footings, *in situ* observations pointed out a 7,0 m thick fill and a water table at 4,0 m depth (Fig. 2). This situation led to changes in the foundation design.

Figure 2. Fill and water table detected during excavations.

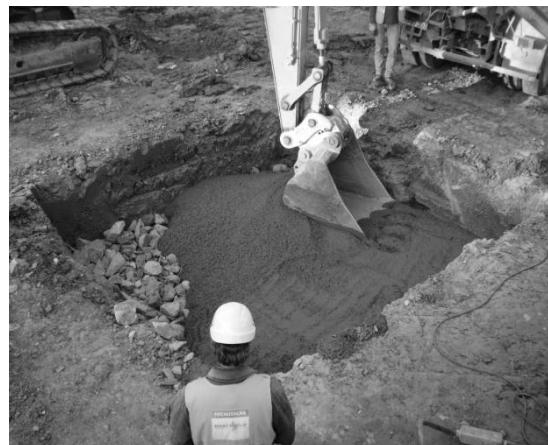
Engineers decided to replace the “weak soil” below 4,0 m in the footing area by cyclopean concrete (Fig. 3) and then made pad footings of 2,0 m thickness.

Figure 3. Cyclopean concrete at the pad footing basement.
